Manhole Inspection Summary

Manhole # S41A1_002MH

Insp Date: **6/4/09 8:43 AM**

Location Address: **1101 E. McCOMAS ST.**

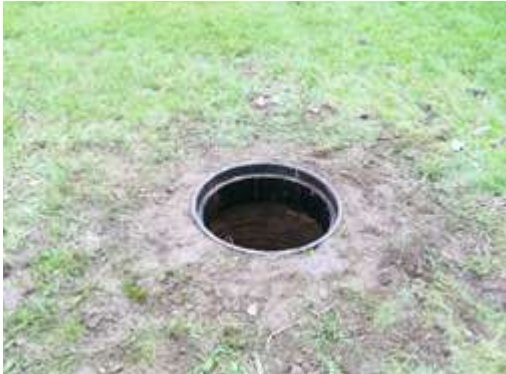
Miscellaneous

FRAME WAS RAISED AND ADJUSTED

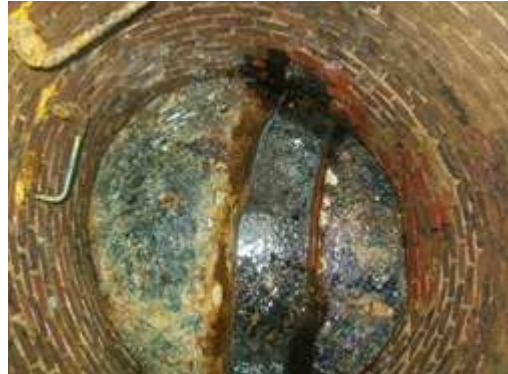
Defect 3

Condition: ☐ Sound ☐ Cracked ☐ Root Intrusion ☐ Loose Brick ☒ **Deteriorated**

Condition: ☐ Sound ☐ Cracked ☐ Root Intrusion ☒ **Deteriorated** ☐ Leaks ☒ **Debris**

Steps Count: **3** Missing: **0** ☒ **Corroded**

bench debris; corroded steps;
deteriorating barrel, bench and channel

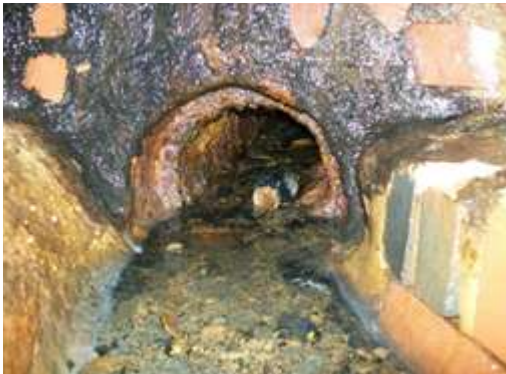
Defect 2

Condition: ☐ Sound ☐ Cracked ☐ Root Intrusion ☒ **Deteriorated** ☐ Leaks ☒ **Debris**

CHANNEL DEBRIS

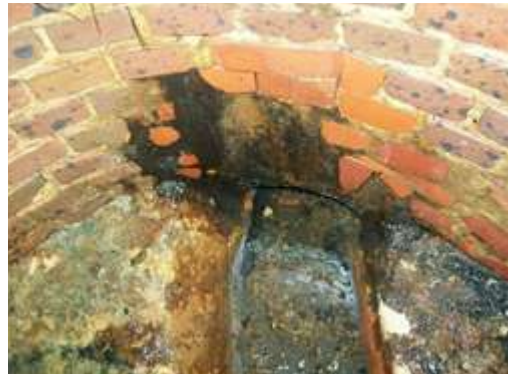
Defect 1

Infiltration: ☐ None ☐ Joint ☐ Cracks ☐ Mortar ☐ Roots ☒ **Wall**

BARREL EVIDENCE OF INFILTRATION

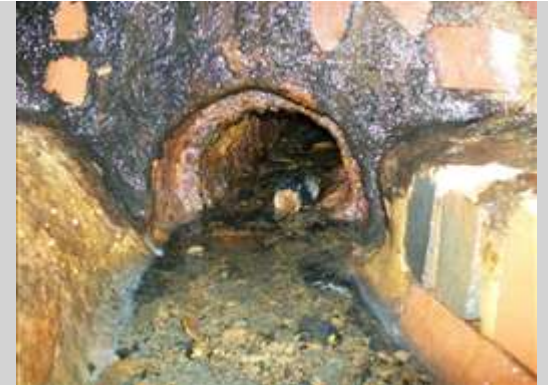
12 O'Clock Outflow

Pipe Height: **8.4** (in.) Rod and Bar (Angled)
Pipe Material: **Clay** ☐ Pipe Lined
Invert Depth: **8.01** (ft.) Flow Characteristics: **Slow**
Deposits: ☐ None ☐ Mud ☐ Sludge ☒ **Debris** ☐ Grease
Silt Depth: **2.5** (in.) Deposits Extent: **Medium**
Infiltration: **Evidence** Pipe Seal Cond: **Unknown**

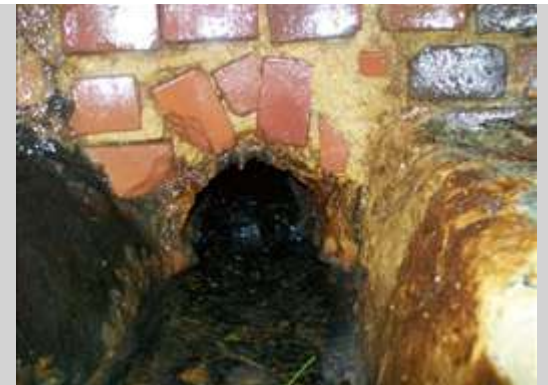
6 O'Clock Inflow

Pipe Height: **8.4** (in.) Rod and Bar (Angled)
Pipe Material: **Clay** ☐ Pipe Lined
Invert Depth: **7.92** (ft.) Flow Characteristics: **Slow**
Deposits: ☐ None ☐ Mud ☐ Sludge ☒ **Debris** ☐ Grease
Silt Depth: **1** (in.) Deposits Extent: **Light**
Infiltration: **None** Pipe Seal Cond: **Cracked**
